FIGURE 20
LABORATORY ANALYTICAL RESULTS: 5-DAY BOD and TOC
ST. LOUIS TUNNEL DISCHARGE CONSTRUCTED WETLAND
PILOT SCALE TEST COMPLETION REPORT

Rico-Argentine Mine Site
Dolores County, Colorado

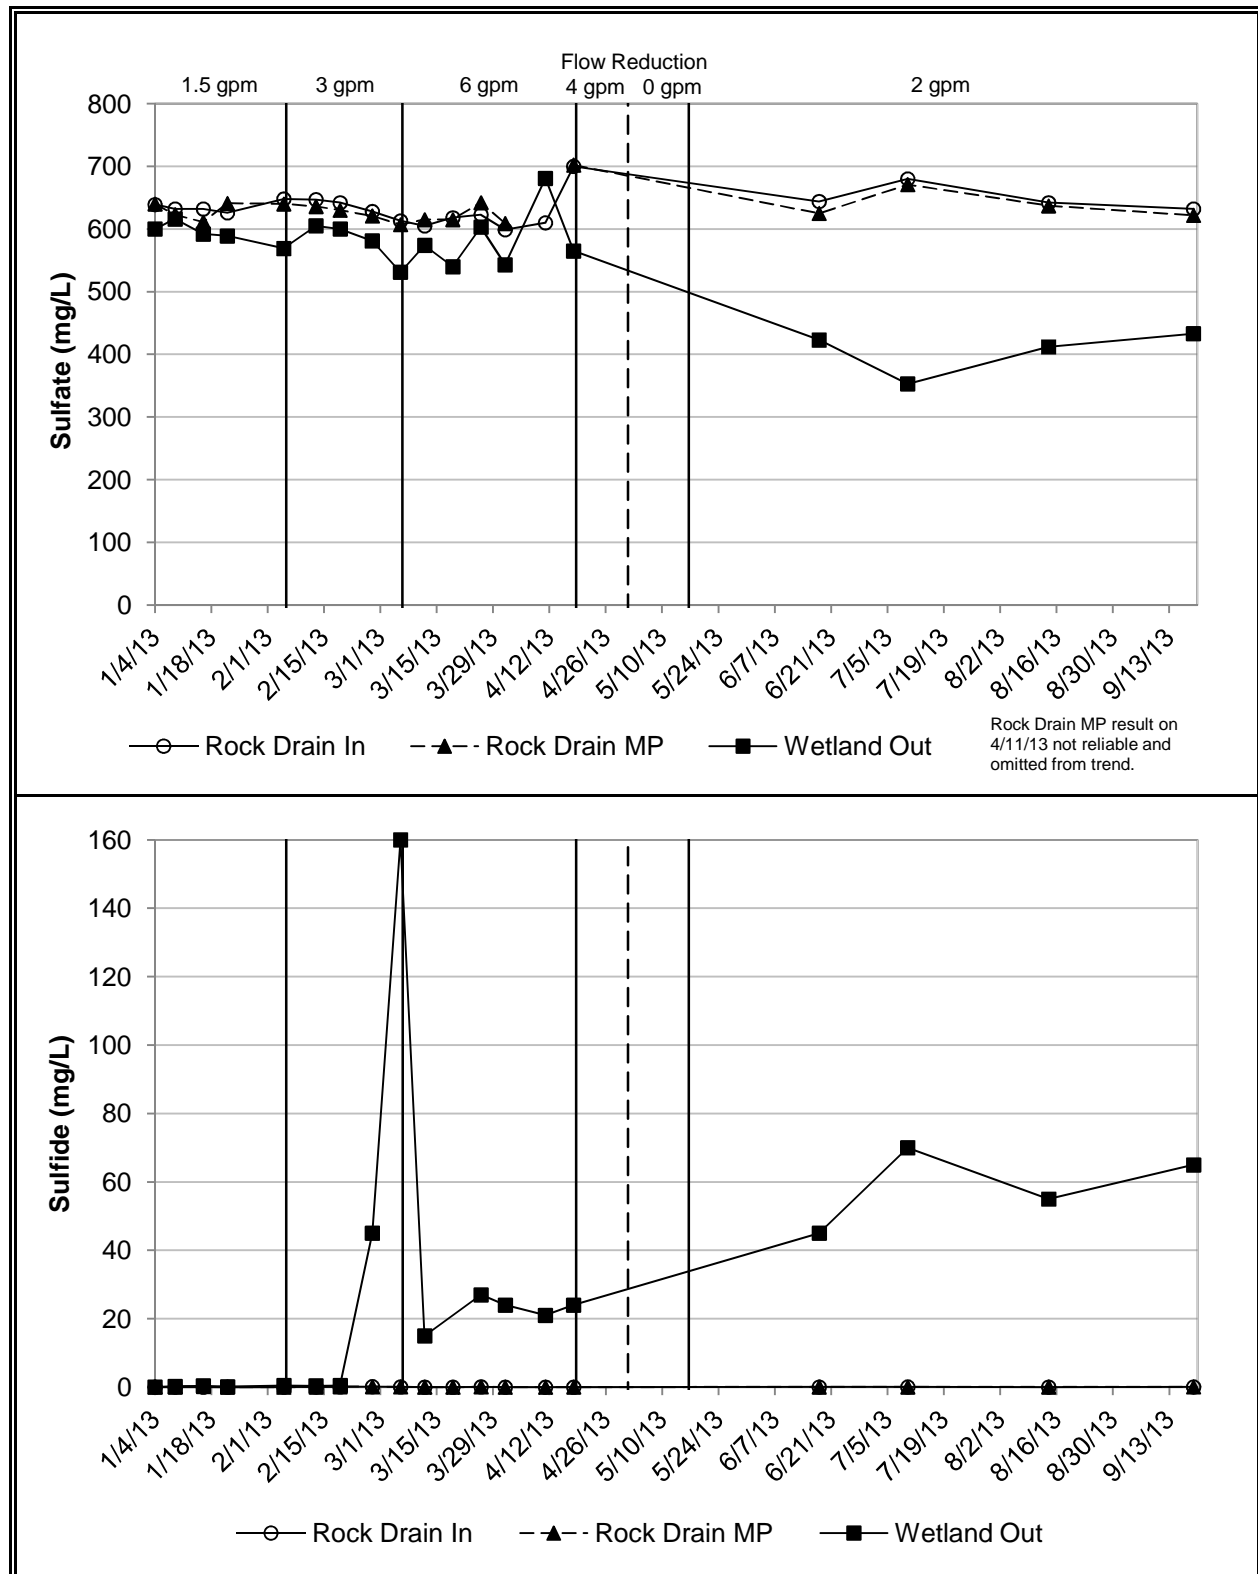
FIGURE 21
LABORATORY ANALYTICAL RESULTS: SULFATE and SULFIDE
ST. LOUIS TUNNEL DISCHARGE CONSTRUCTED WETLAND
PILOT SCALE TEST COMPLETION REPORT

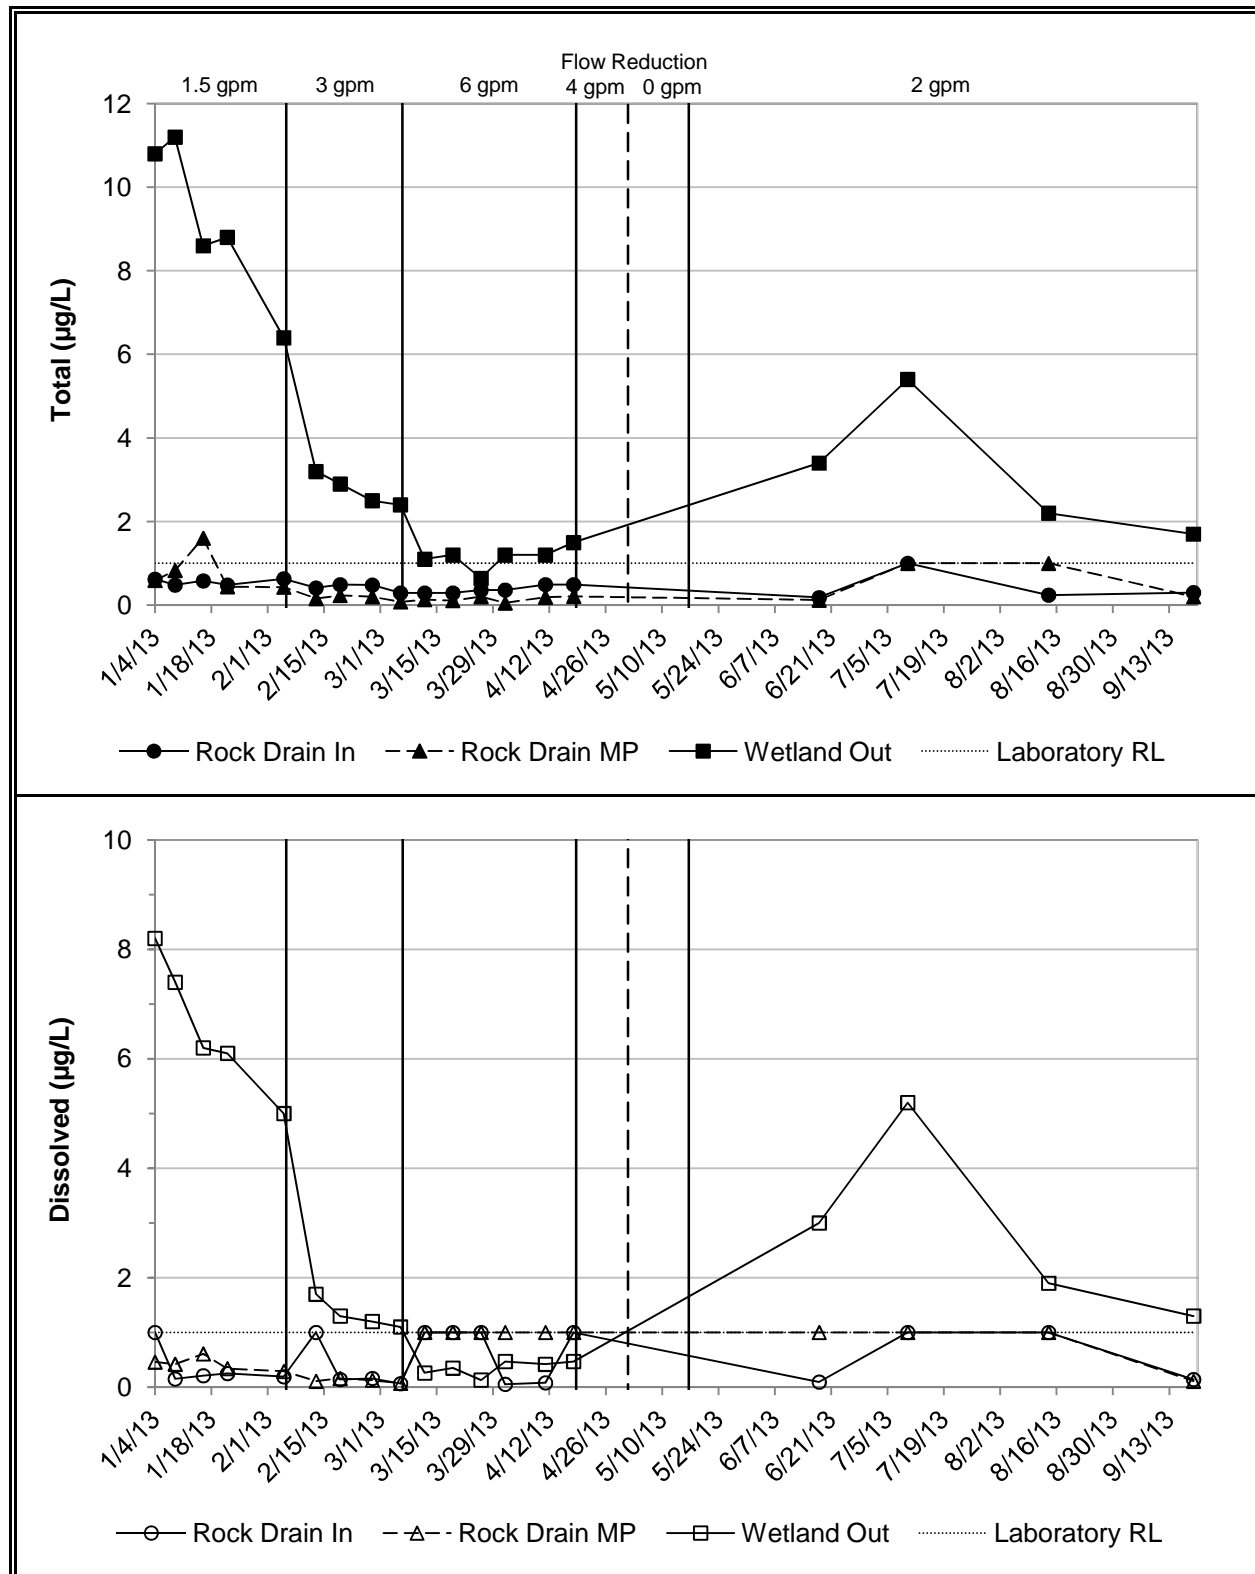
FIGURE 22
LABORATORY ANALYTICAL RESULTS: ARSENIC
ST. LOUIS TUNNEL DISCHARGE CONSTRUCTED WETLAND
PILOT SCALE TEST COMPLETION REPORT
 Rico-Argentine Mine Site
 Dolores County, Colorado

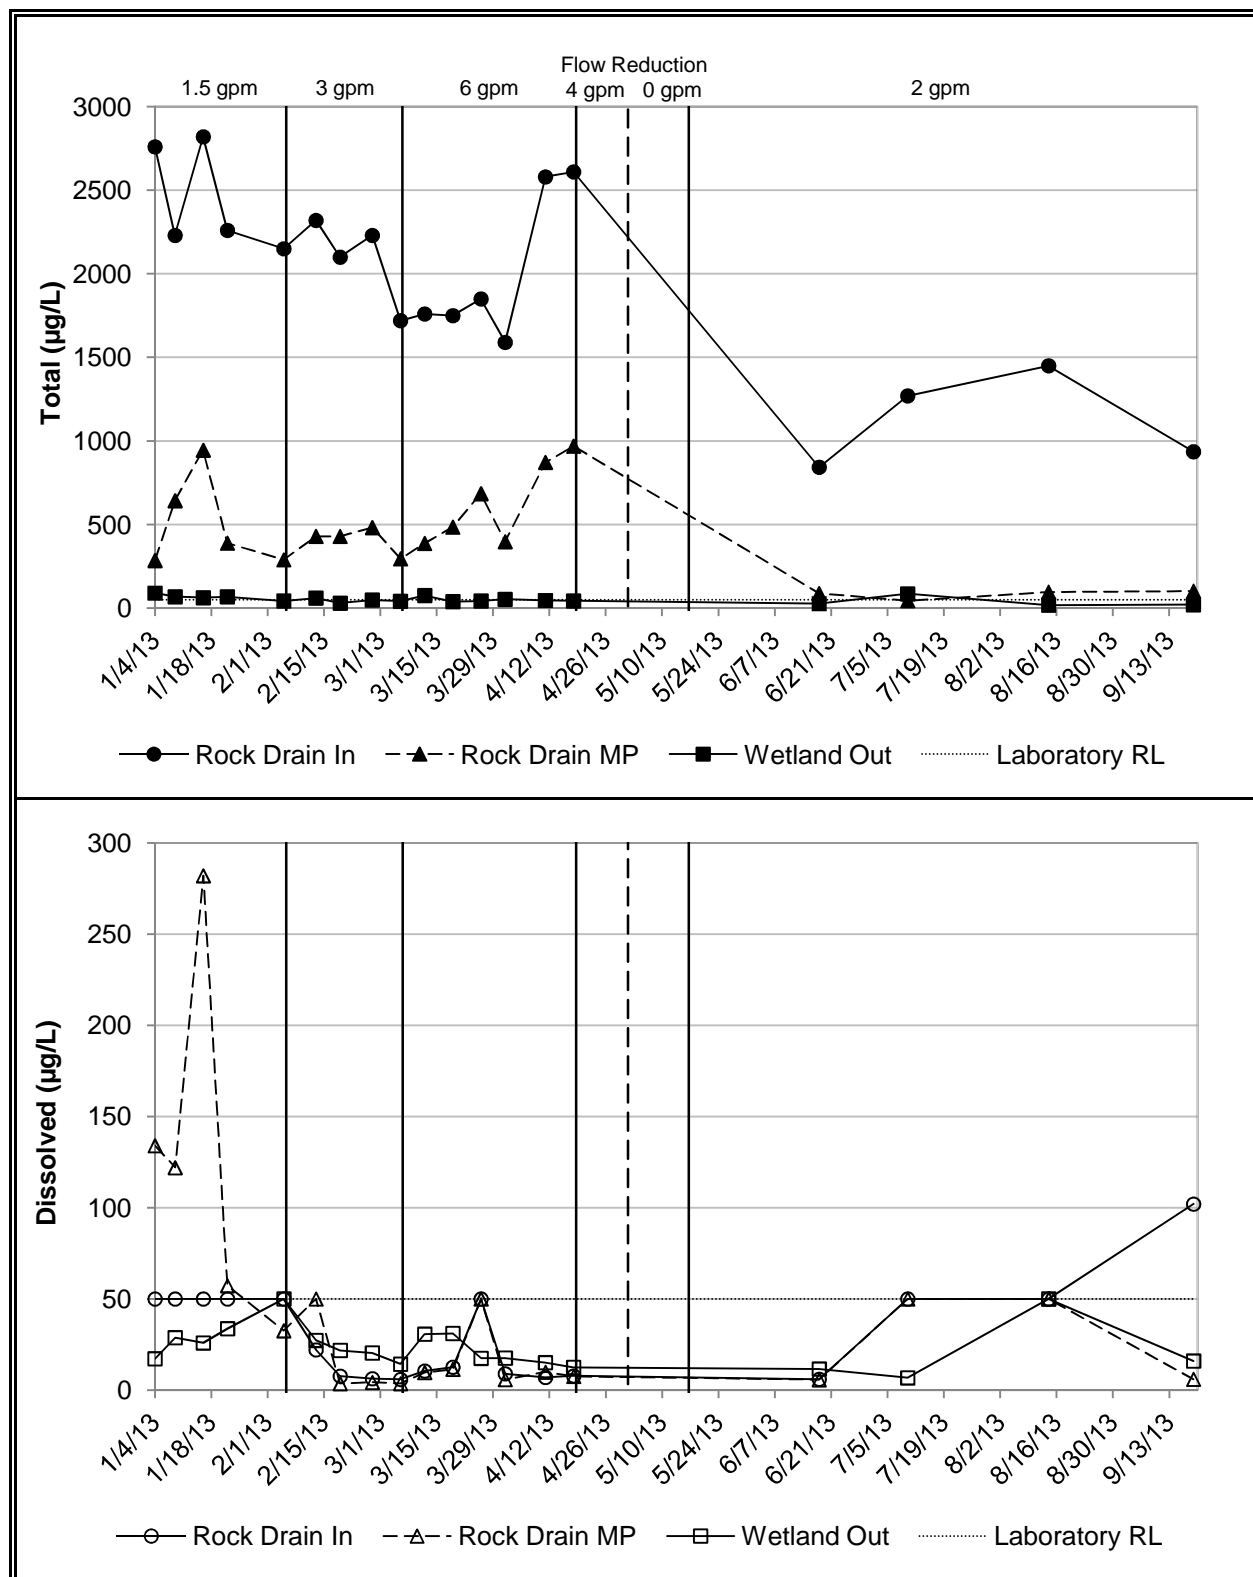
FIGURE 23
LABORATORY ANALYTICAL RESULTS: IRON
ST. LOUIS TUNNEL DISCHARGE CONSTRUCTED WETLAND
PILOT SCALE TEST COMPLETION REPORT

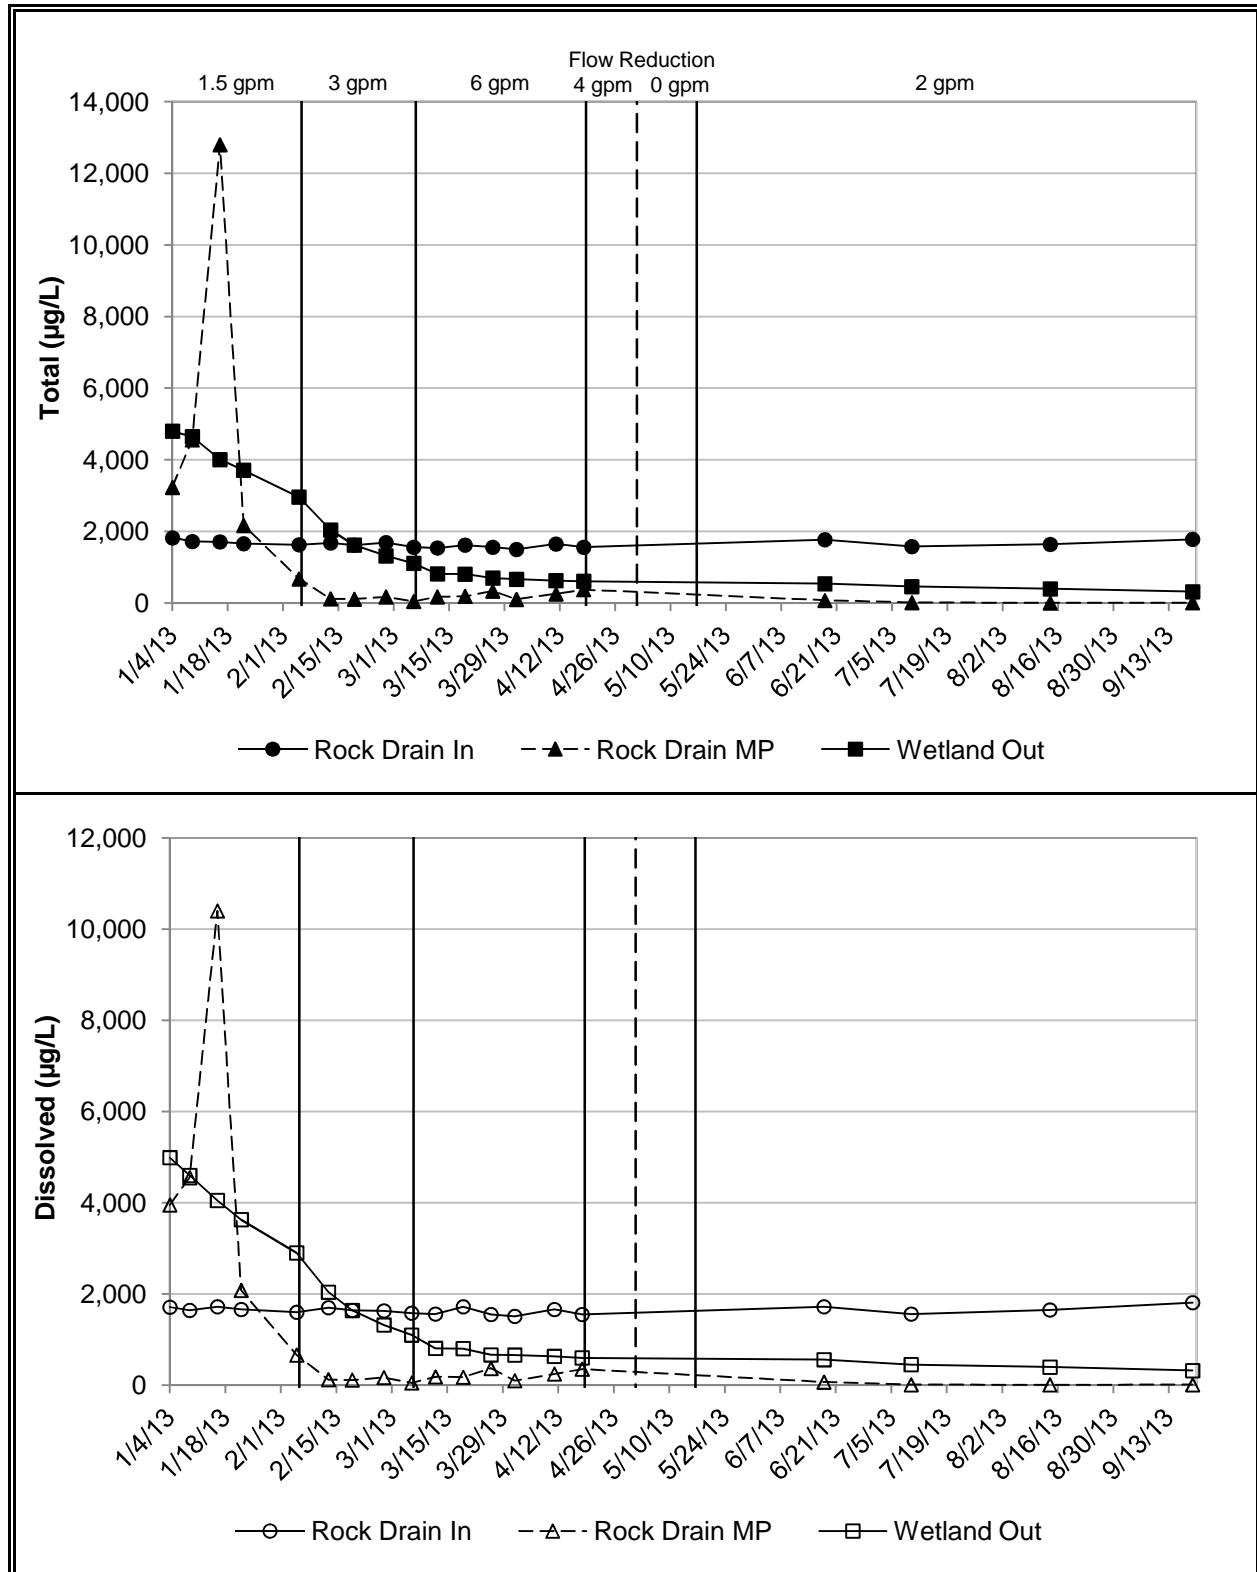
FIGURE 24
LABORATORY ANALYTICAL RESULTS: MANGANESE
ST. LOUIS TUNNEL DISCHARGE CONSTRUCTED WETLAND
PILOT SCALE TEST COMPLETION REPORT

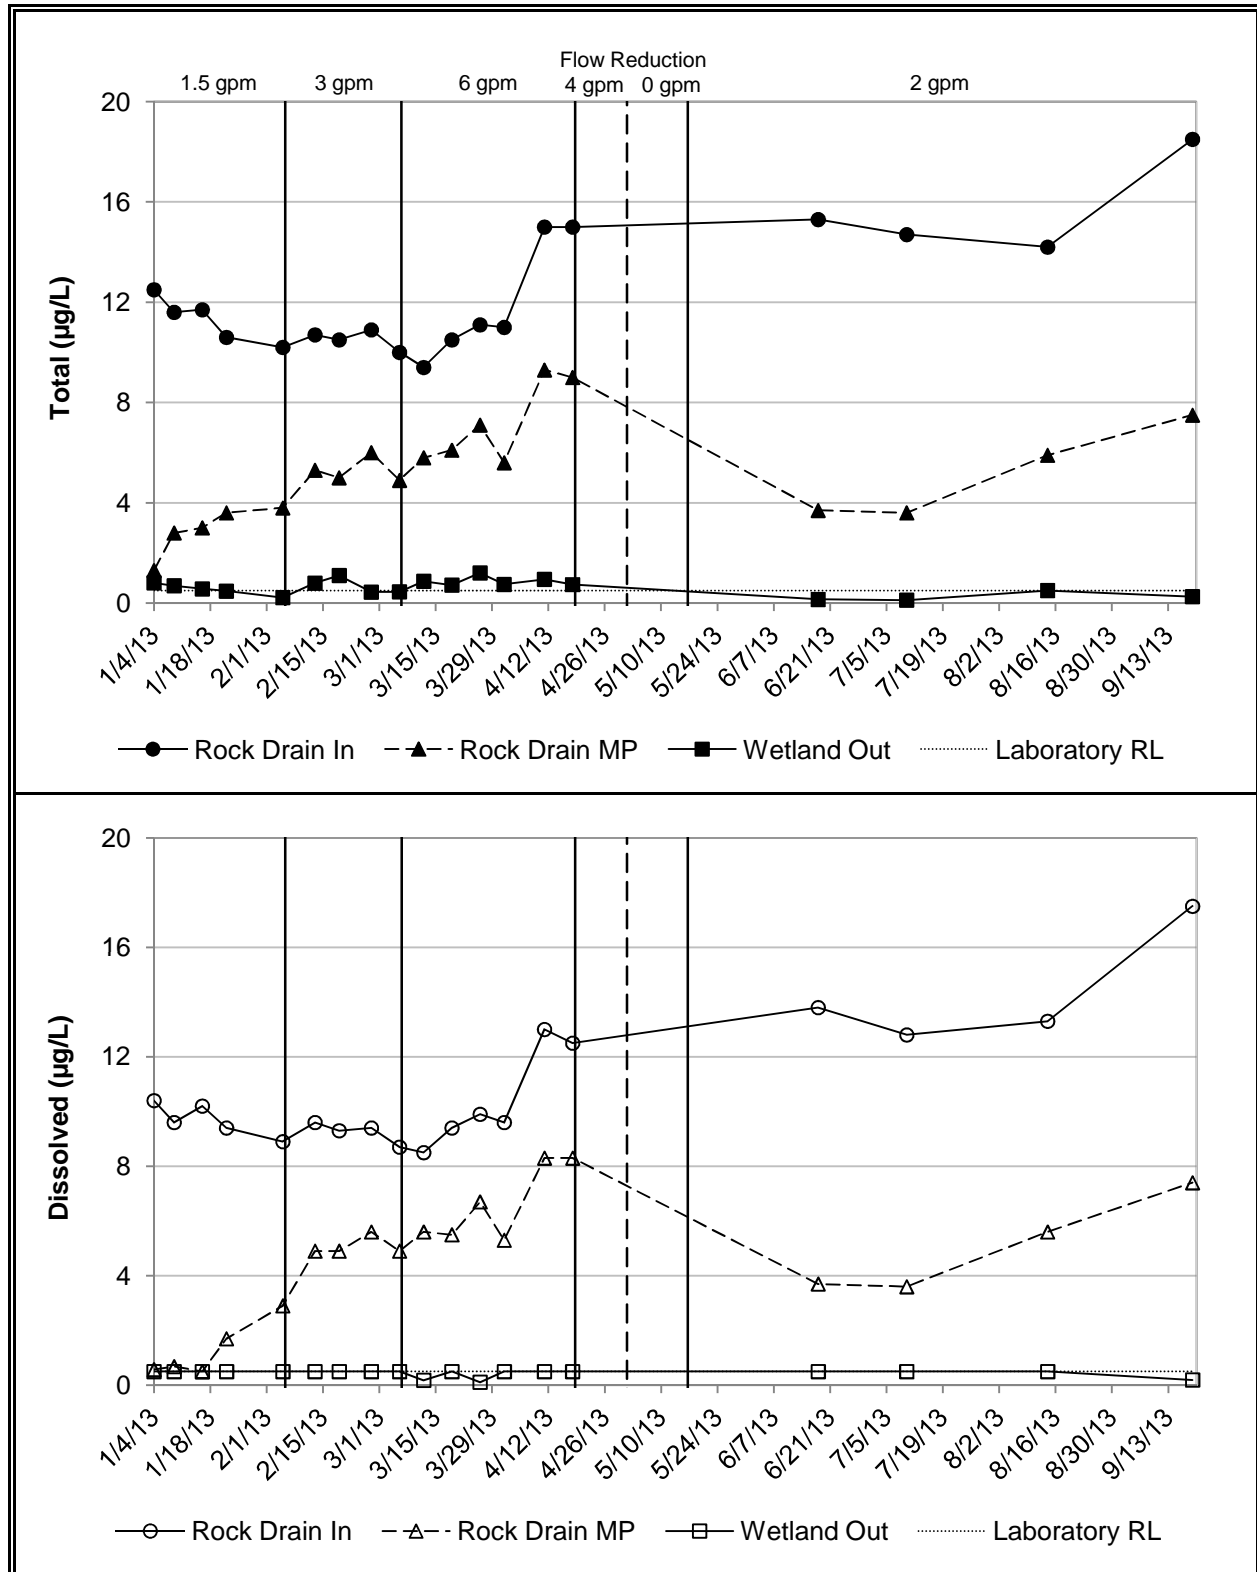
FIGURE 25
LABORATORY ANALYTICAL RESULTS: CADMIUM
ST. LOUIS TUNNEL DISCHARGE CONSTRUCTED WETLAND
PILOT SCALE TEST COMPLETION REPORT
 Rico-Argentine Mine Site
 Dolores County, Colorado

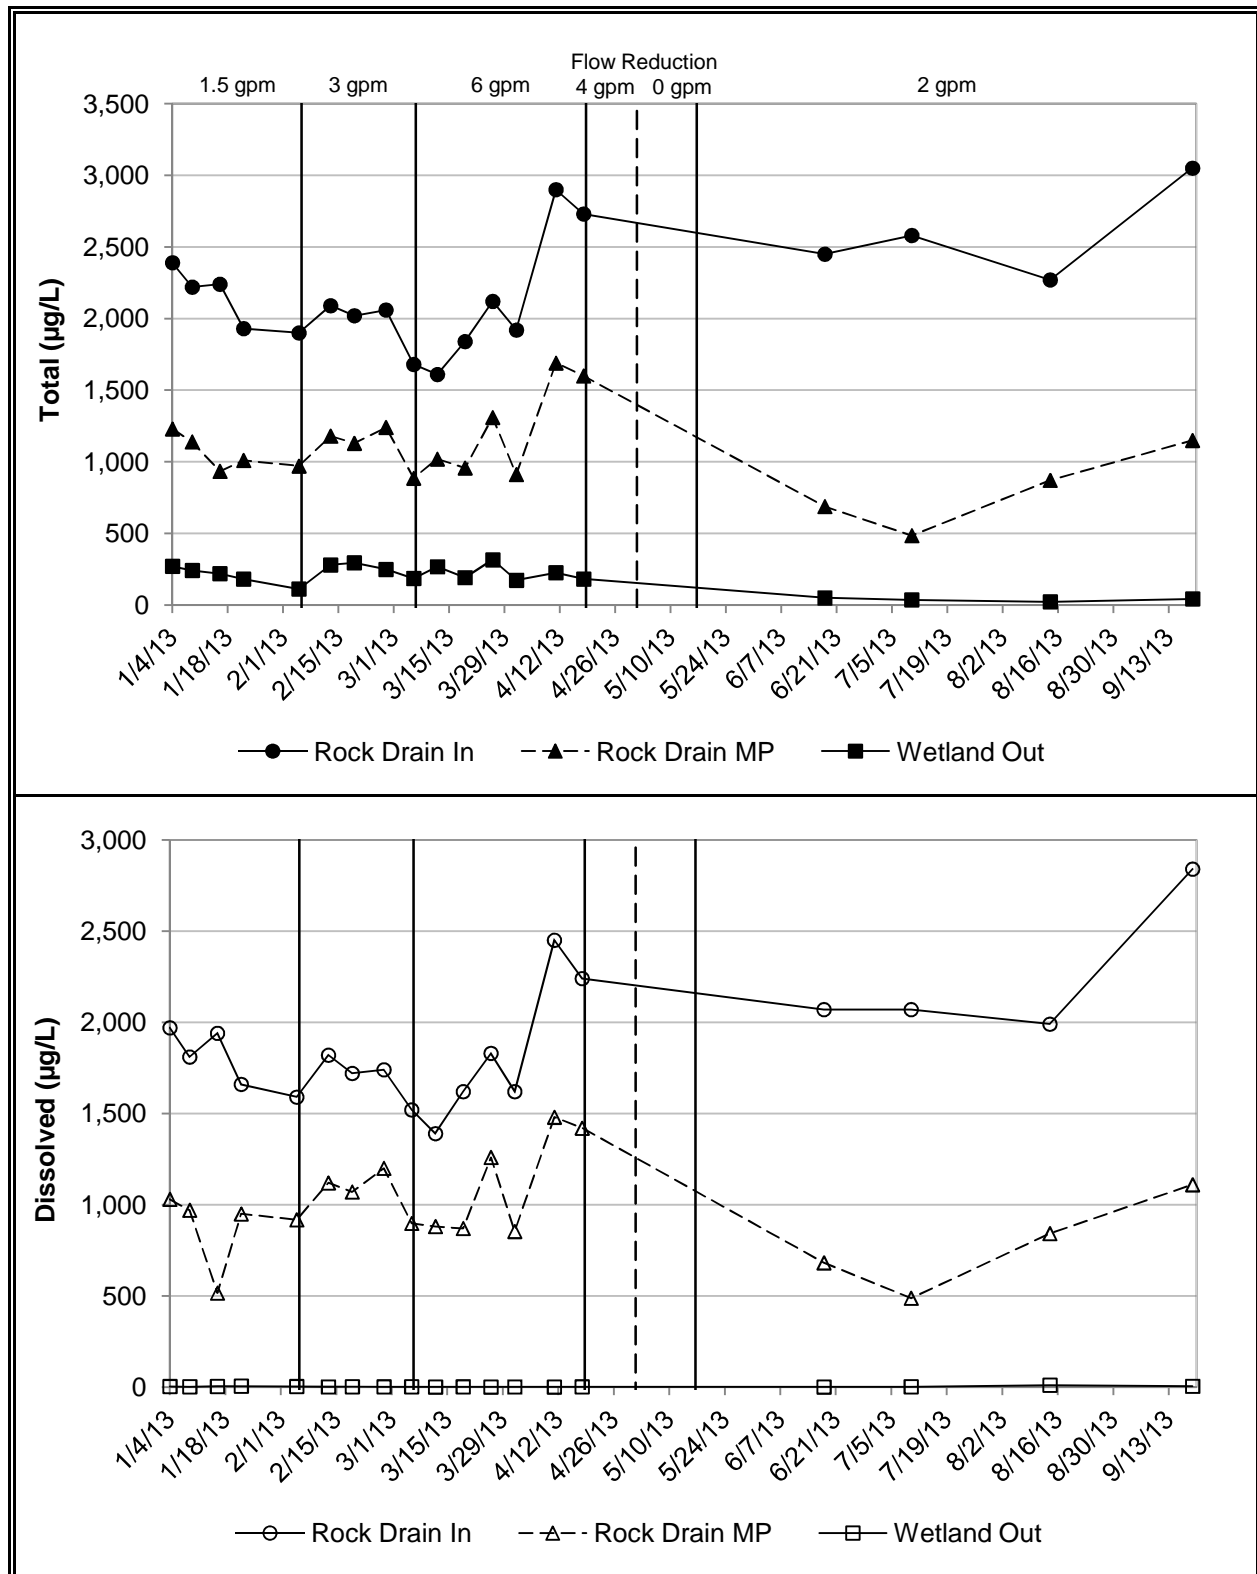
FIGURE 26
LABORATORY ANALYTICAL RESULTS: ZINC
ST. LOUIS TUNNEL DISCHARGE CONSTRUCTED WETLAND
PILOT SCALE TEST COMPLETION REPORT
